Technical Information

01 / 2003

911 GT3 Cup - 2003 Model

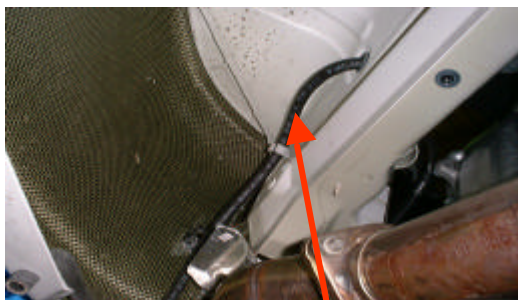
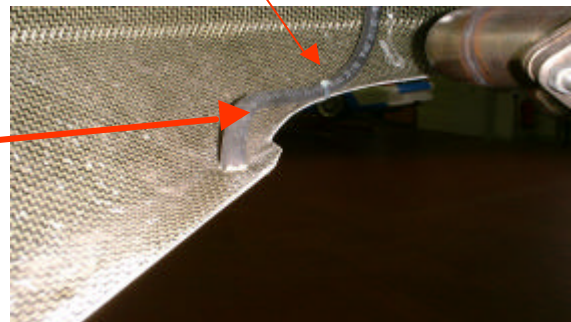
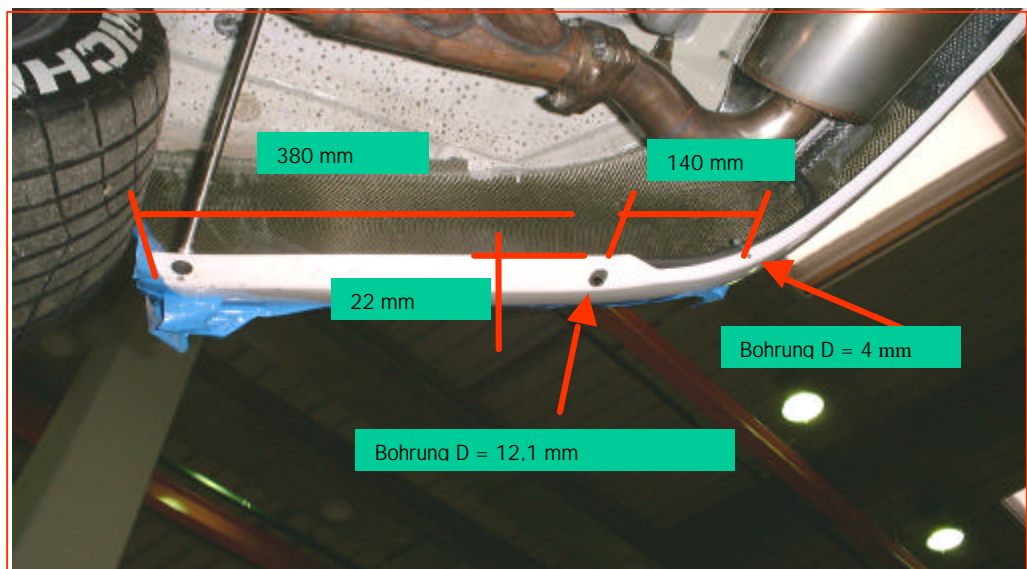
The ventilation hose for the steering oil tank turned out to be too short. Spilling oil might reach the exhaust manifold. We therefore recommend to mount the hose delivered to you according to the following mounting instructions:

Befestigung mit Kabelbinder
N.020.904.4

Entlüftungsschlauch
996.201.152.92

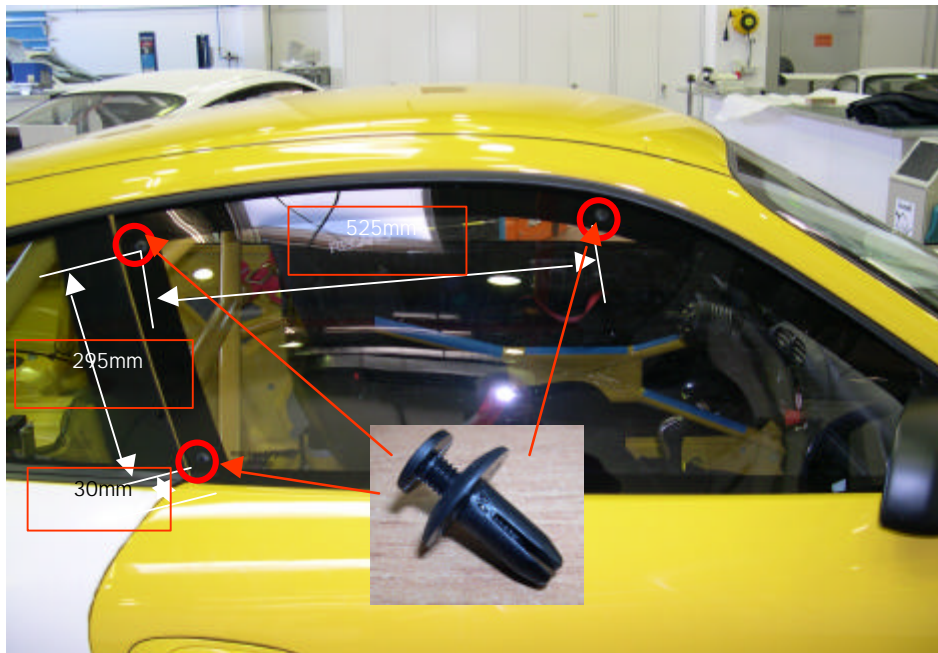
Mechanical fixing

The bonding of side window / door frame may dissolve due to high air temperature and humidity. We recommend to additionally fix the front side windows mechanically. The part number of the clip fastener is 996.542.875.90.
